## TRANSMISSION MAIN IMPROVEMENTS TOWN OF MARCELLUS JANUARY 2016

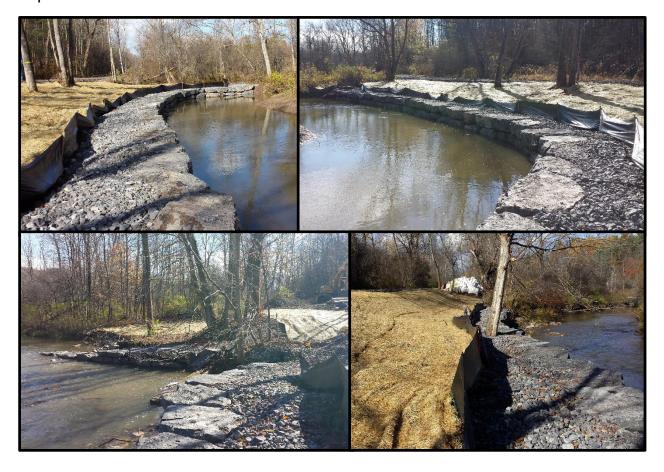
Examples of the restored Site 1 and Site 2 in Marcellus:

There are five sites that required repair. Two of the five were completed in the fall of 2015 and are shown below. The other three are schedule to be completed in 2016 and 2017.

- Use of natural stone for primary armoring of the area.
- Restoration of existing streambed features for habitat through the installation of turning vanes (which create pools behind them while also serving to direct the energy of the water away from the pipe) and stone riffles (which recreate the conditions observed in the stream prior to the project).
- The disturbed areas were re-seeded with seed mixes specifically designed for wetland areas to help reestablish the appropriate native plant species.
- Areas with the erosion control fabric were planted with "live stakes", which are
  essentially live, nursery grown, cuttings of native woody plant species that get
  hammered into the ground like a spike. These self-root and quickly establish the
  woody growth that would be expected on a stream bank of this nature.
