CAMILLUS AREA TRANSMISSION MAIN IMPROVEMENTS
TOWN OF CAMILLUS
MARCH 2017

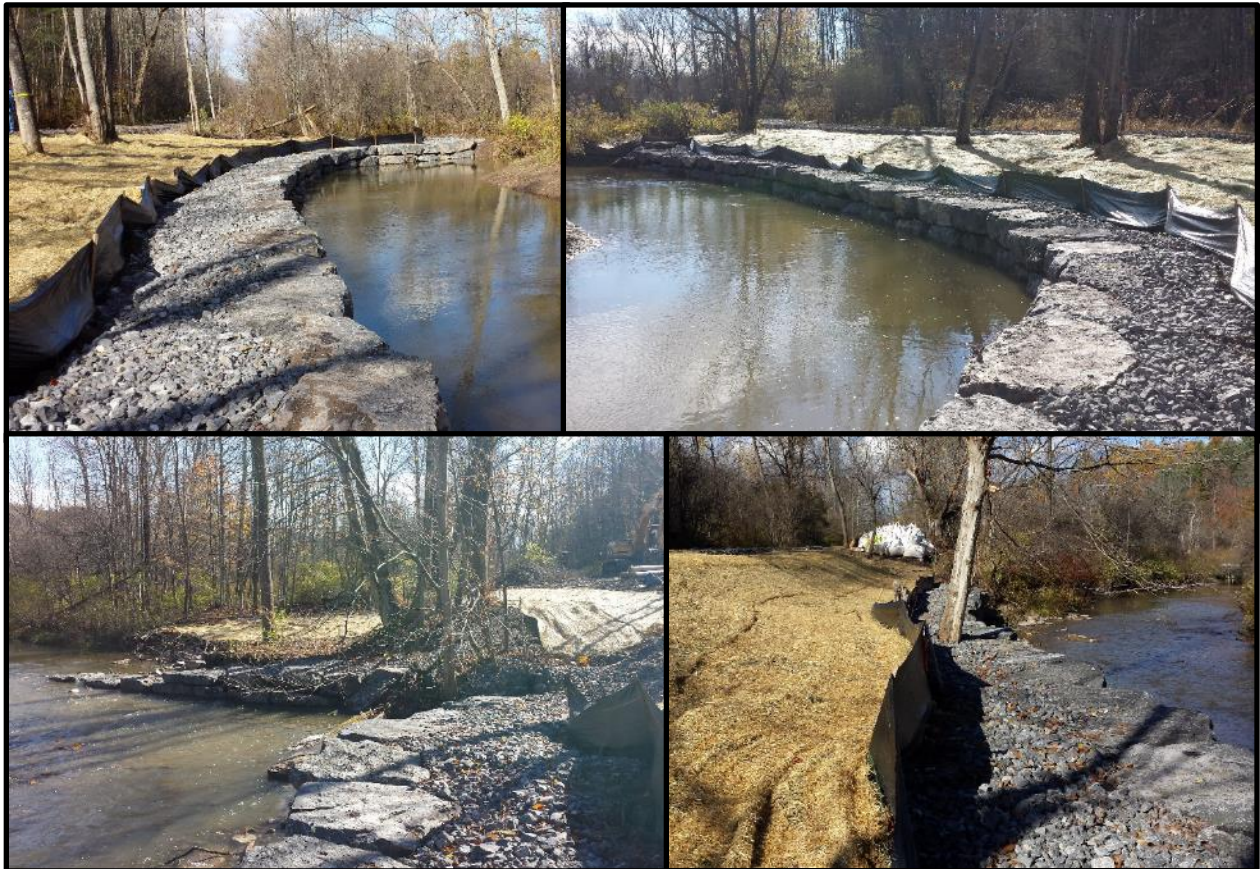
Examples of the restored Site 1 and Site 2 in Marcellus:

- Use of natural stone for primary armoring of the area (see other OCWA restoration projects herein for examples).
- Restoration of existing streambed features for habitat through the installation of turning vanes (which create pools behind them while also serving to direct the energy of the water away from the pipe) and stone riffles (which recreate the conditions observed in the stream prior to the project).
- Integration of tree and root-ball components into the design to provide additional habitat along the streambank while also serving to reduce the energy and minimize erosion.
- Reseeding of disturbed areas with seed mixes specifically designed for wetland areas to help reestablish the appropriate native plant species.
- Areas with the erosion control fabric were planted with "live stakes", which are essentially live, nursery grown, cuttings of native woody plant species that get
